# Post-seismic Effectiveness of the Strengthening Work Carried Out with GFRP Applied to Historical Masonry Buildings: The Case Study of the Spoleto Cathedral

Alessandro Grazzini<sup>1 (\*)</sup>, Stefano Agnetti<sup>2</sup>

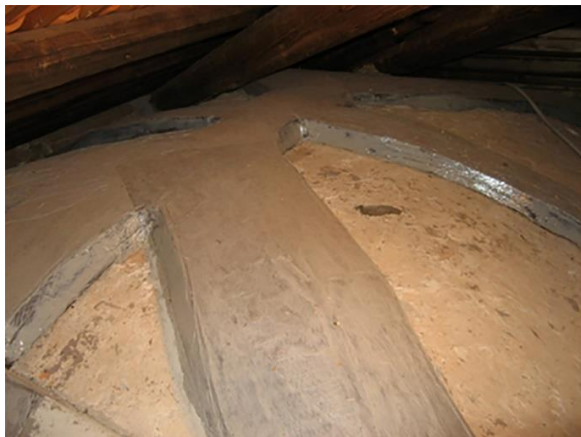
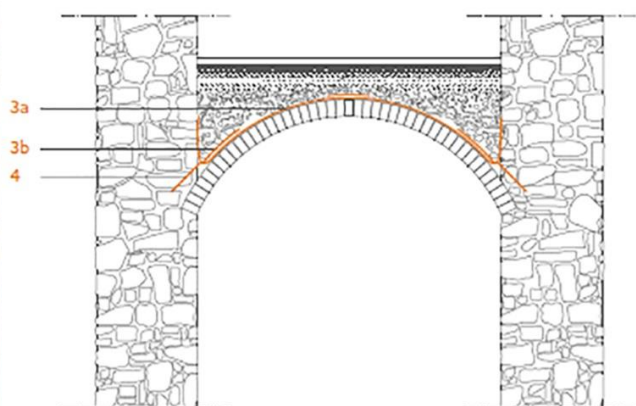
**Figure 5.** FRP Strengthening vault from the extrados.

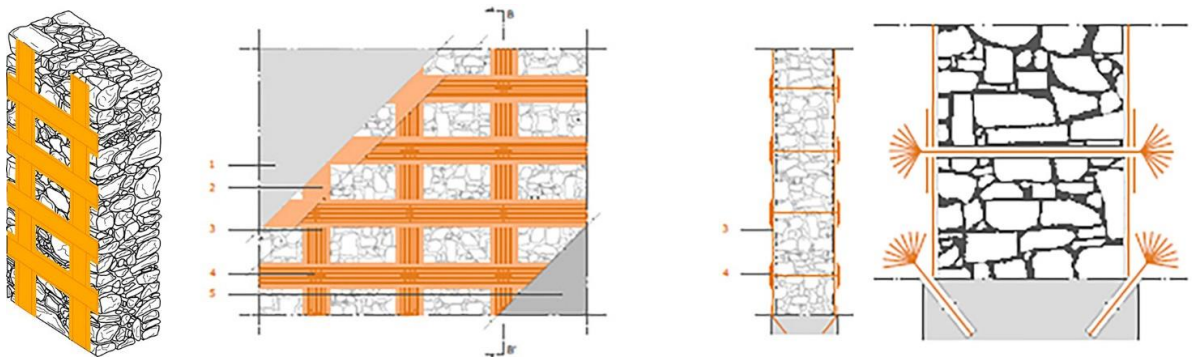
**Figure 6.** Reinforced (flexural and shear) masonry panel by FRP glued bands.

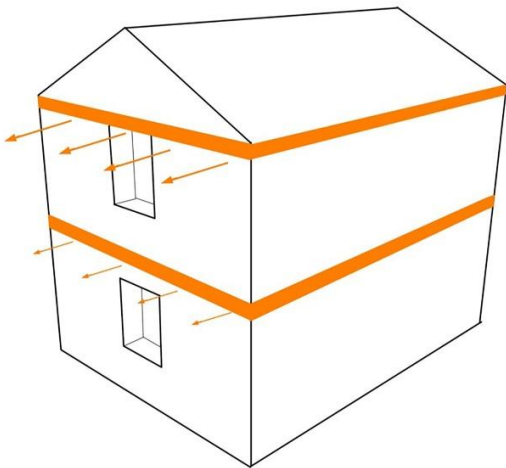
**Figure 7.** Reinforcement circle buildings made by FRP bands for the contrast of out of plane in masonry vulnerable to seismic action.
